FACTUAL REPORT OF INVESTIGATION

AT: - Land at Shirley Close, Cheshunt, Herts. EN8 9PS

JOB No: - BL3961

**INTERPRETIVE REPORT ON
SITE INVESTIGATION
AT
LAND AT SHIRLEY CLOSE,
CHESHUNT, HERTS, EN8 9PS**

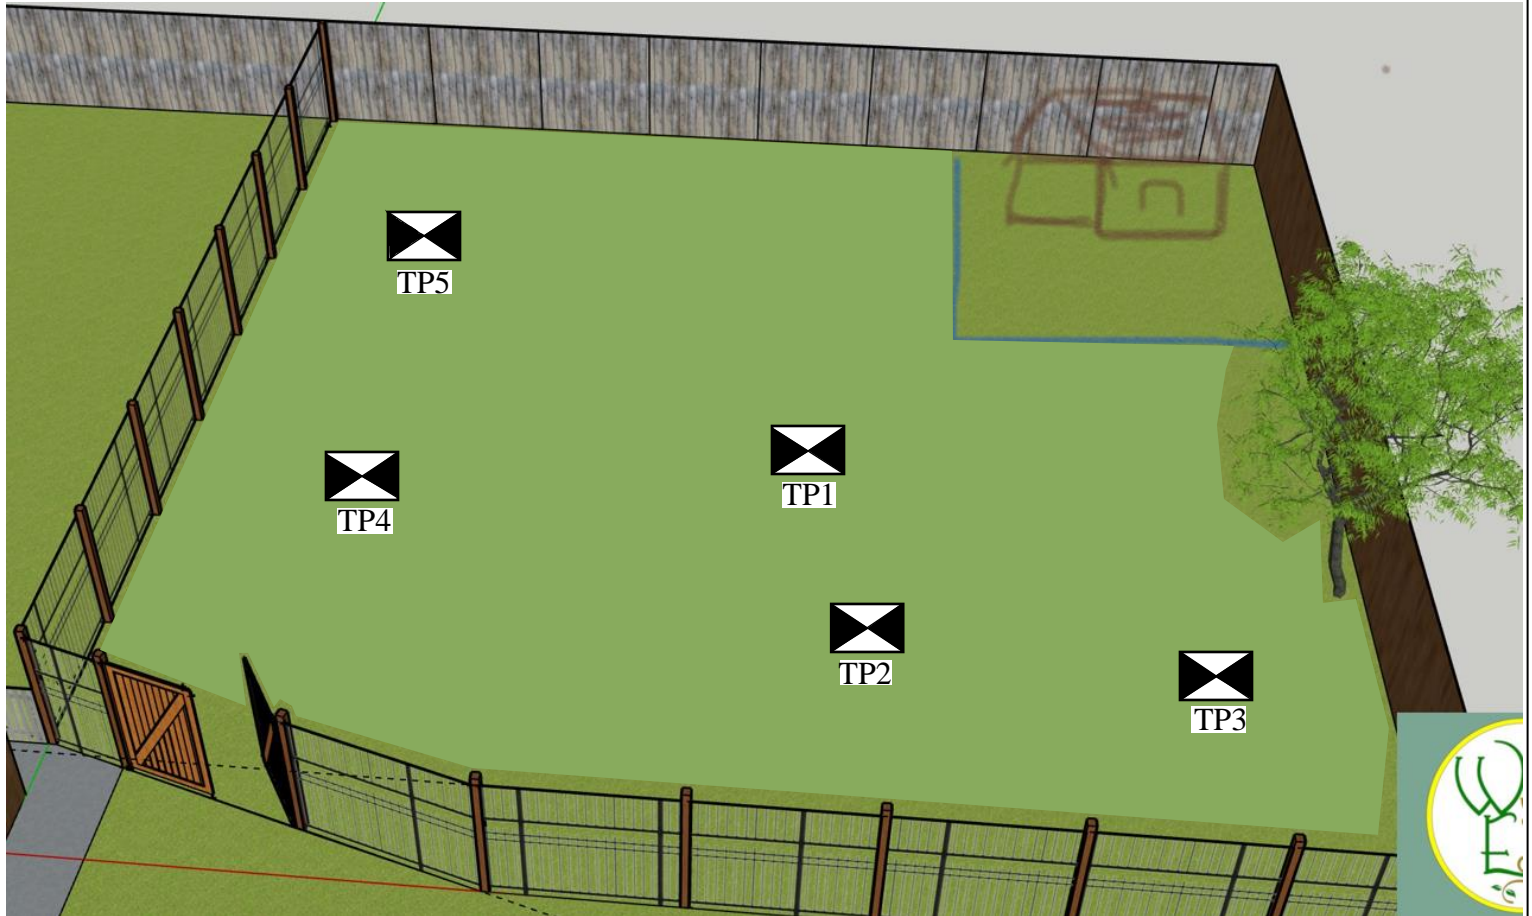
Site Location Plan

- 3.1 The layout of the site and location of the five sampling points, which are labelled TP1 to TP5 inclusive, is indicated on the site plan forming part of the Factual Report.
- 3.2 The sampling point trial pits can be summarised as revealing fill material to between 100mm and 600mm overlying a gravelly sandy silty clay typical of Enfield Silt Member, possibly mixed with sands and gravels.
- 3.3 Tub and jar samples were taken at 300mm in TP1, in the top 100mm in TP2, at 100mm in TP3, 150mm in TP4, and again at 150mm in TP5. Each of these was placed in a cool box and sent to ELAB for contamination analysis.

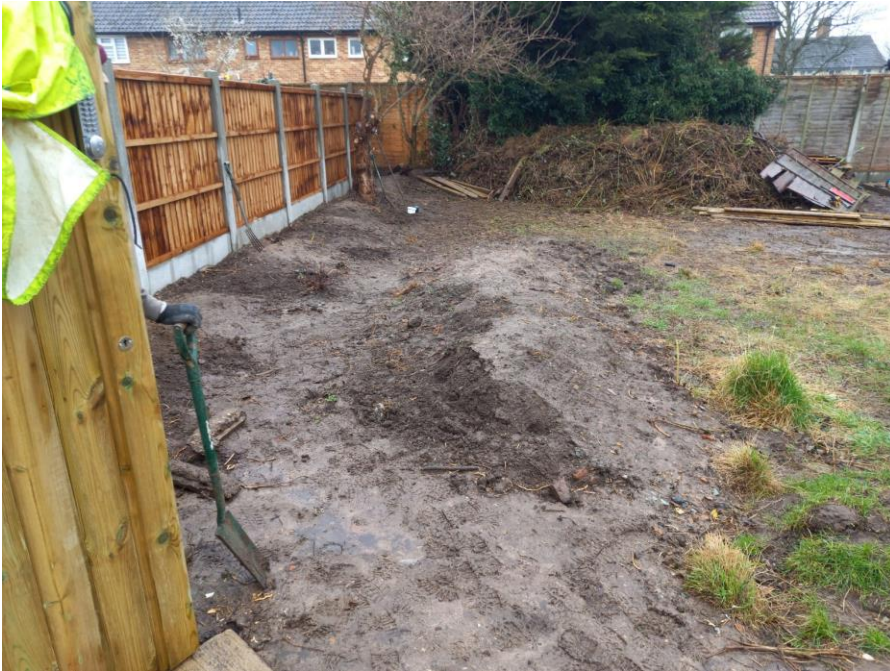
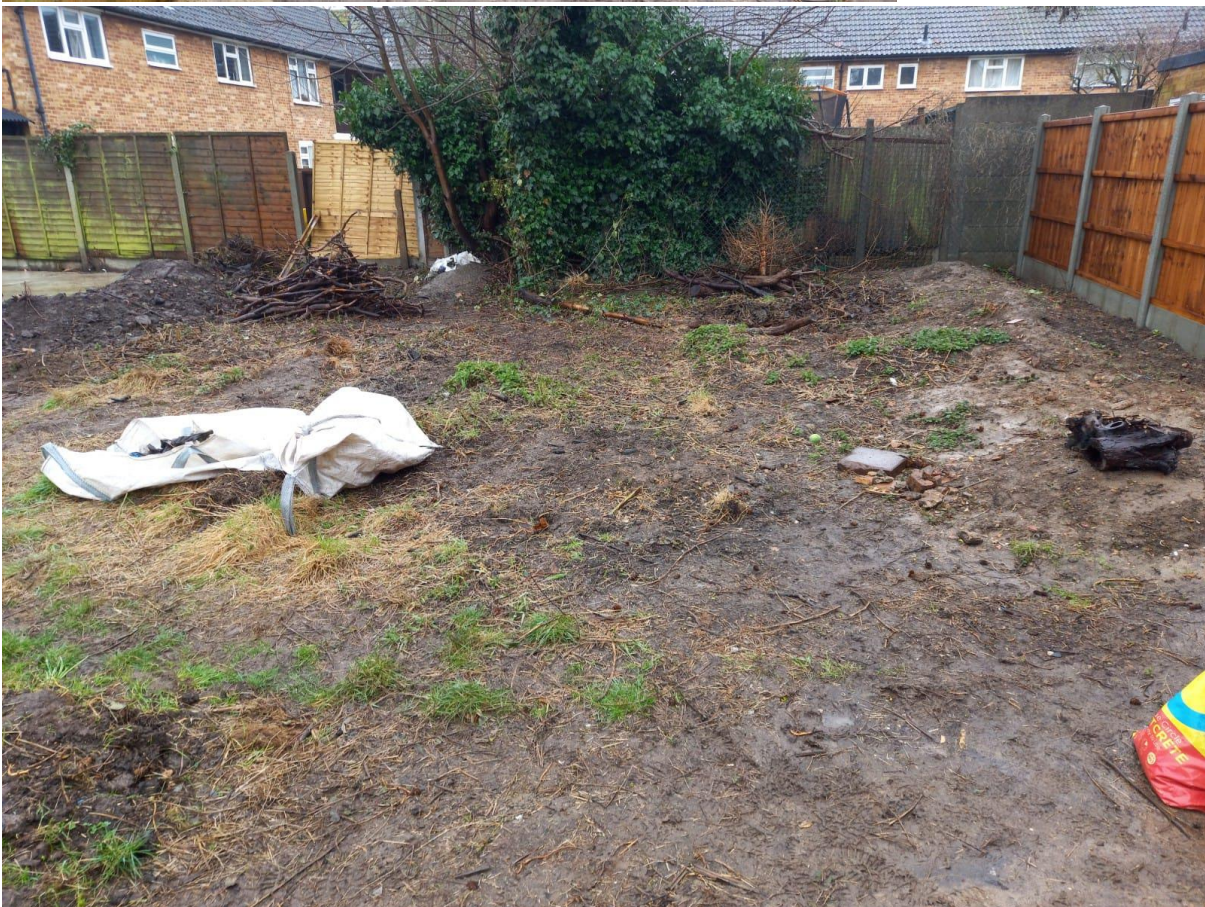
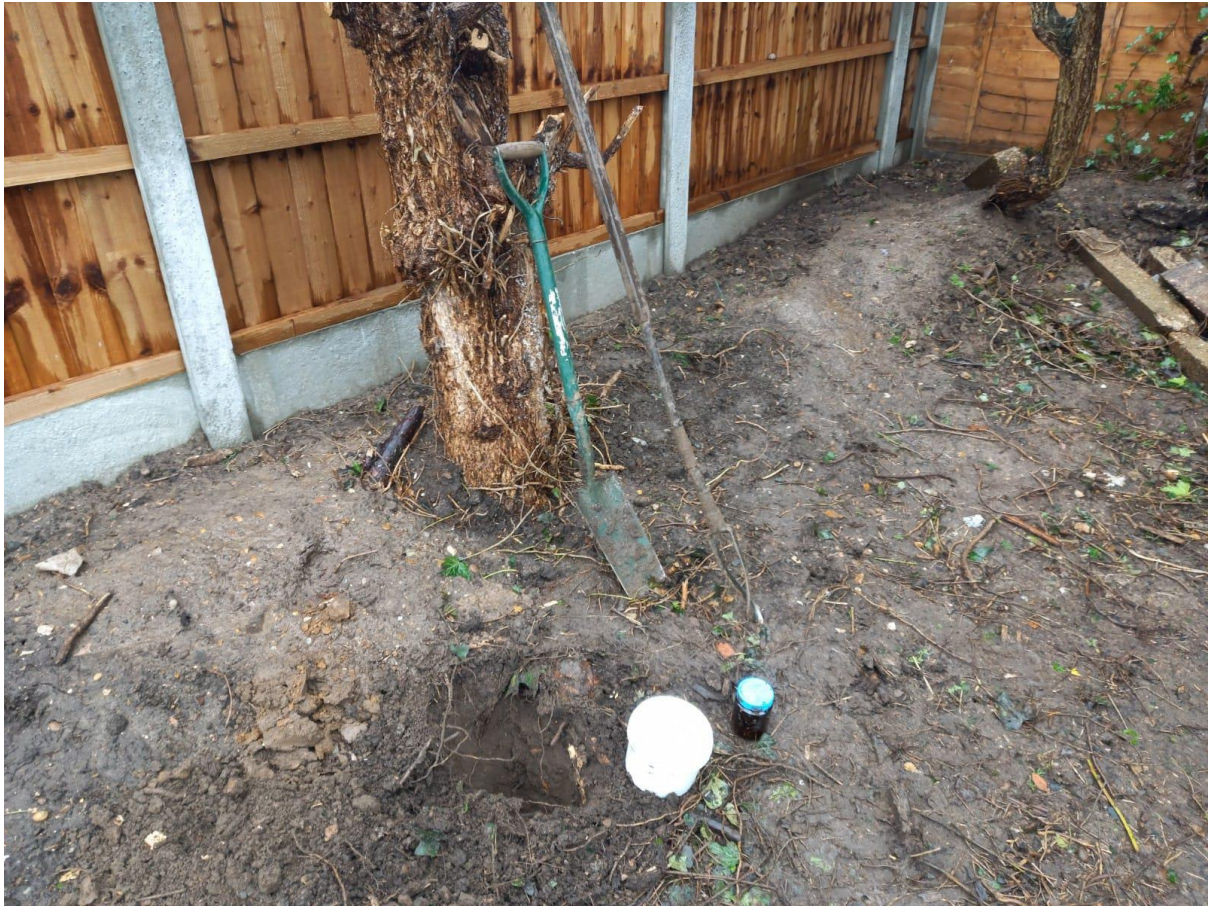
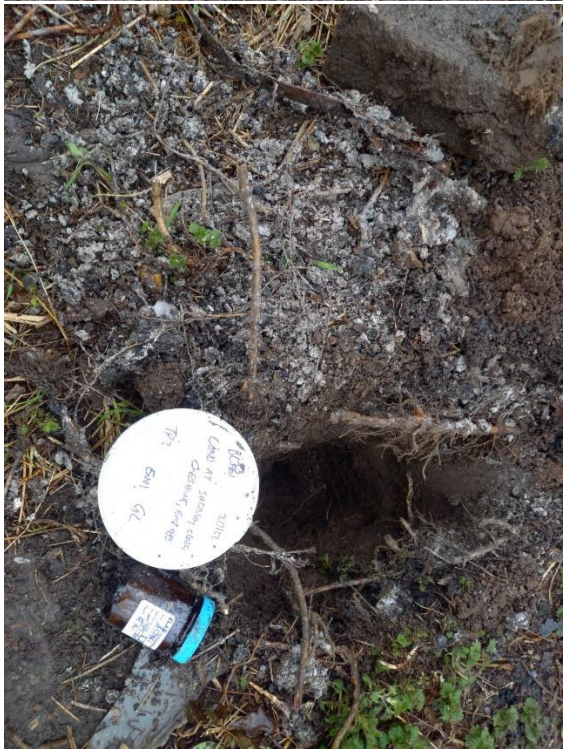
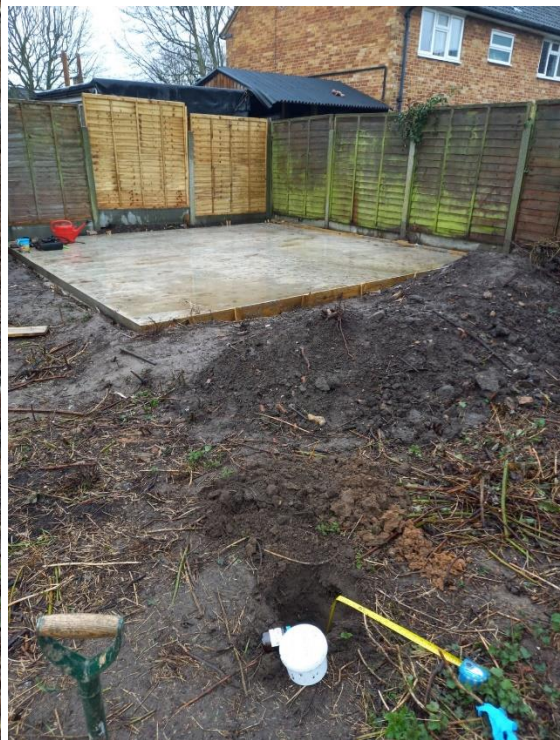
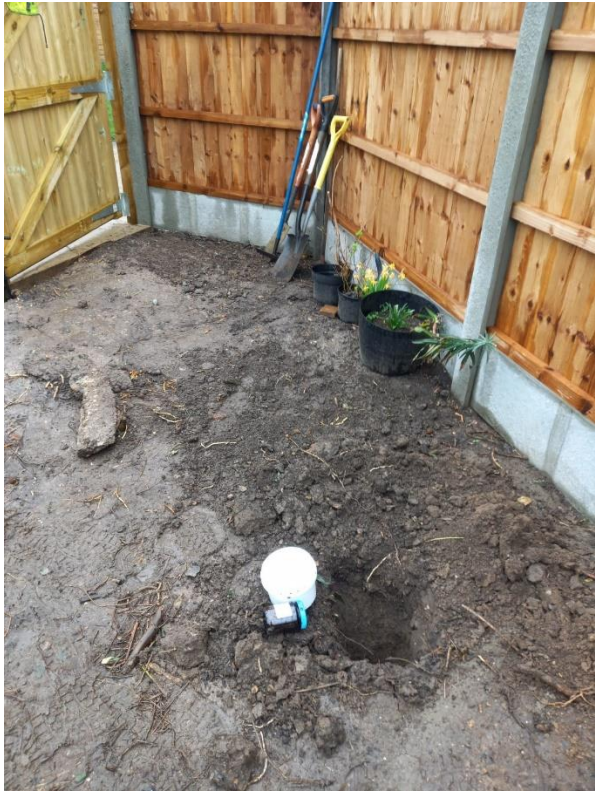
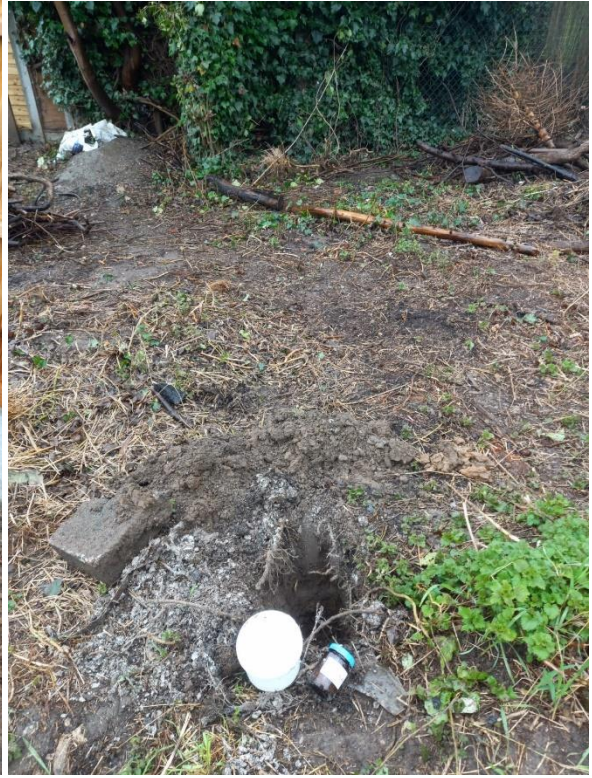
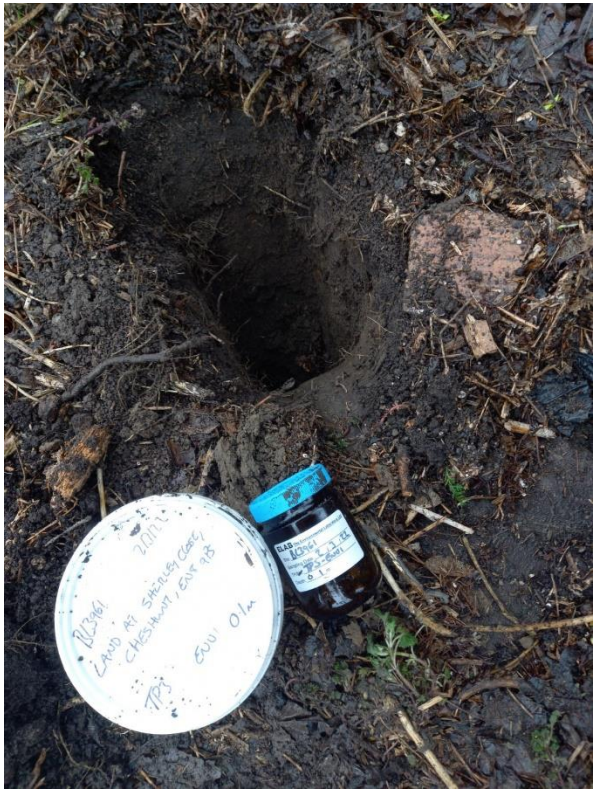
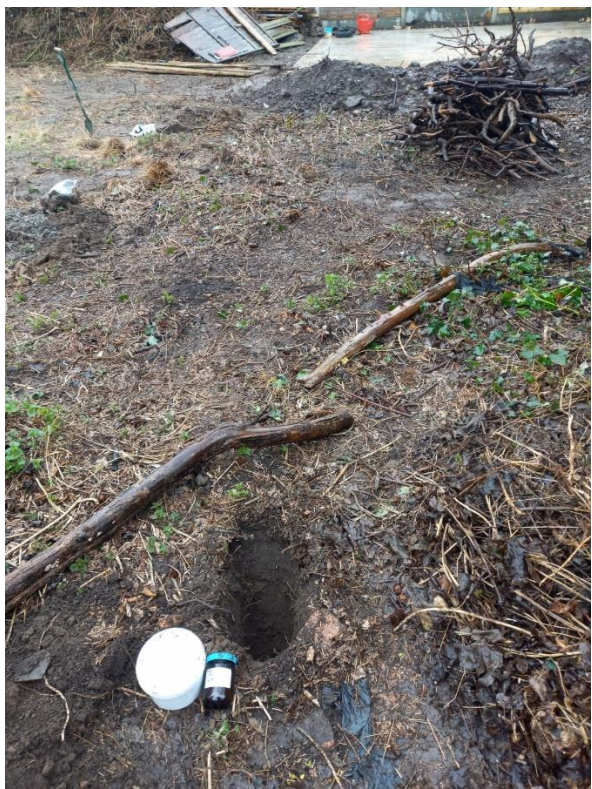
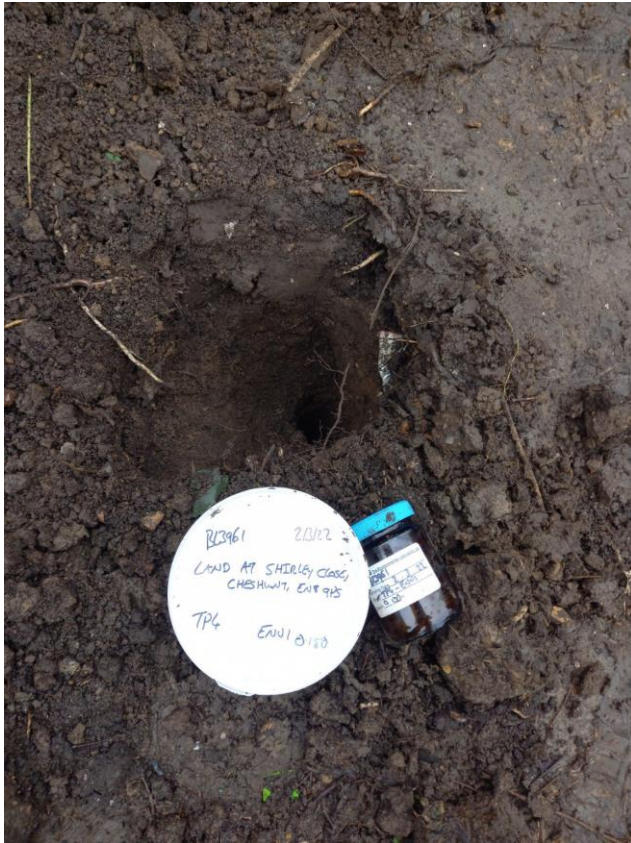
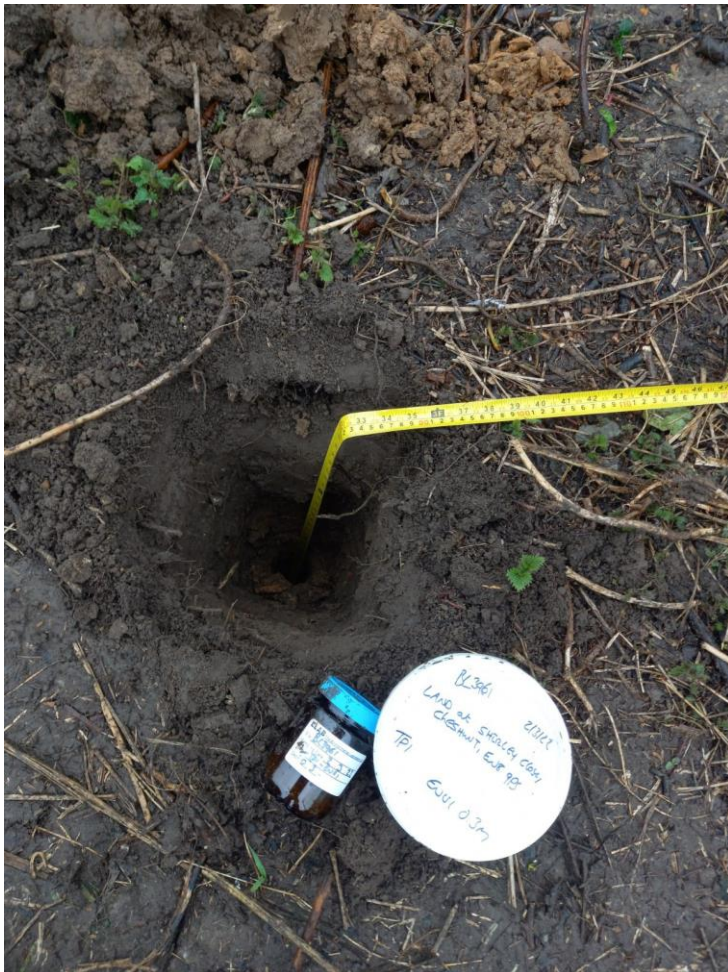
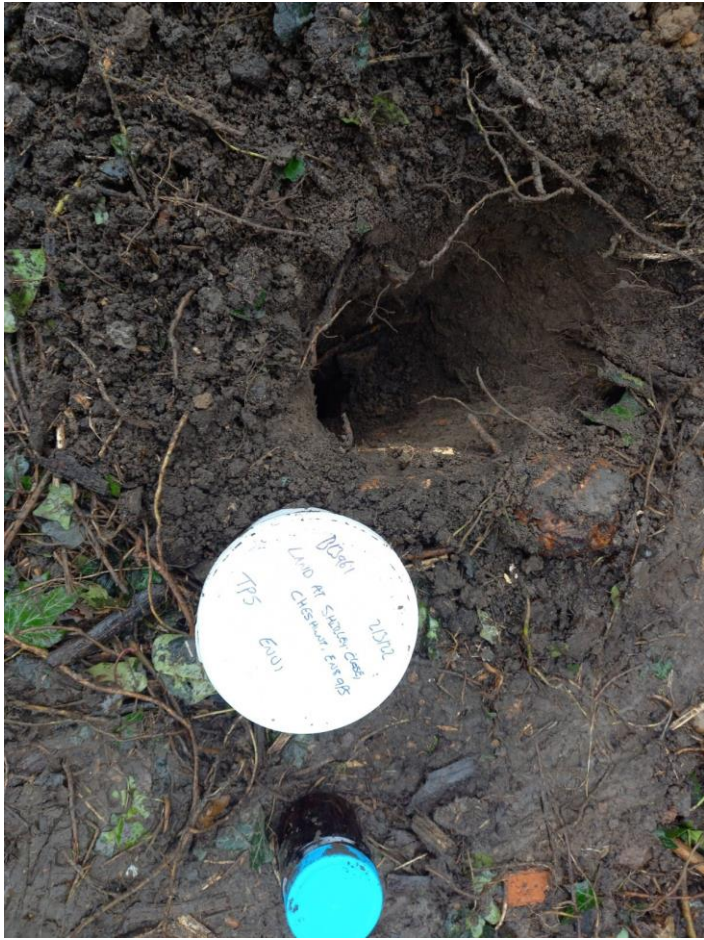
Photos taken 2.3.2022

- 1.3 We have not visited the site and our comments are based entirely on the information provided. This is a site plan showing the location of five trial pits for the sampling, the logs of these trial pits, laboratory soil testing by ELAB and some photographs of the site taken during the course of the site work.

- 5.2 It is unlikely, in our view, that there would be contamination to the natural ground. The depth to the natural ground is nowhere more than 600mm and so our recommendation is that the fill material should be removed down to the natural ground and this should then be replaced by clean inert subsoil and topsoil to meet the requirements of an allotment and from a reliable source.
